Whatcom County Drainage Improvement District #30 Drainage Management Plan

Drainage Improvement District #30

Whatcom Conservation District

Whatcom County Public Works

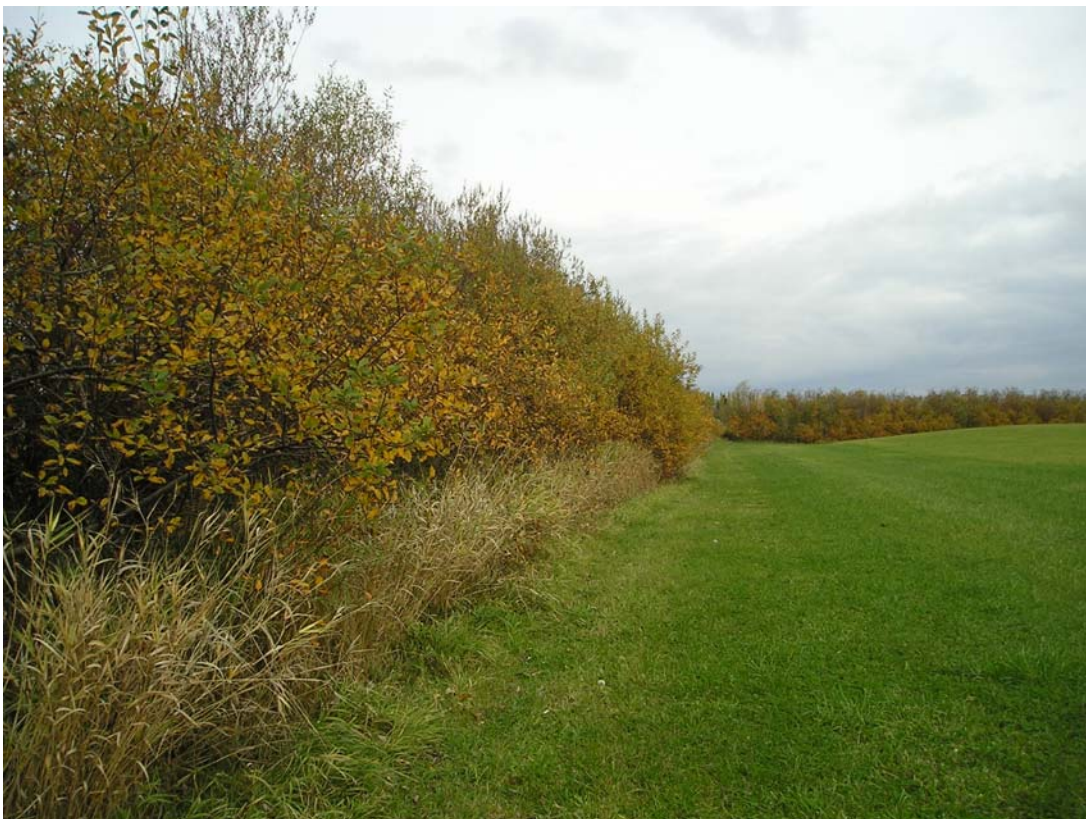
Hedgerow along a Modified Natural Watercourse in DID#30

Modified Natural Watercourses (Yellow): Silver Creek (Andreason Ditch) is a maintained district channel. 6,250 feet. In addition, 680 feet of Andreason Ditch is maintained downstream from the DID #30 boundary.

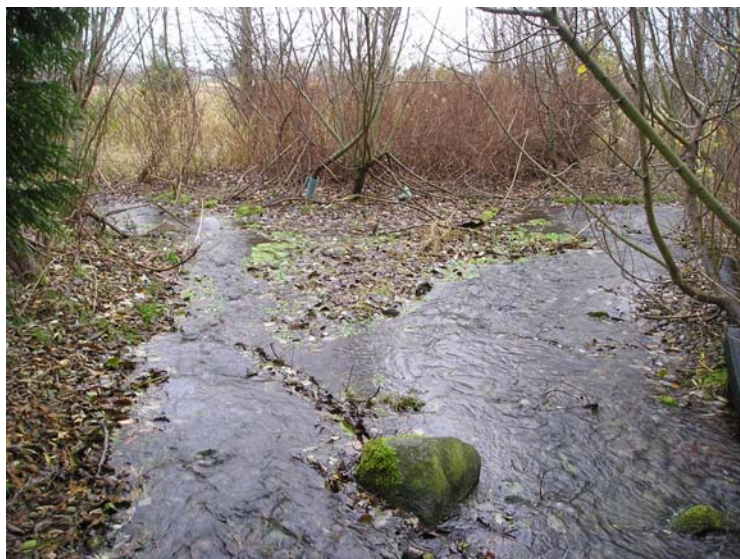
Silver Creek (left) & Deer Creek (right) rock diversion

Other Infrastructure – A rock diversion exists near the northwest district boundary. Water from Larrabee springs is divided into the headwaters of both Silver Creek and the south fork of Deer Creek.

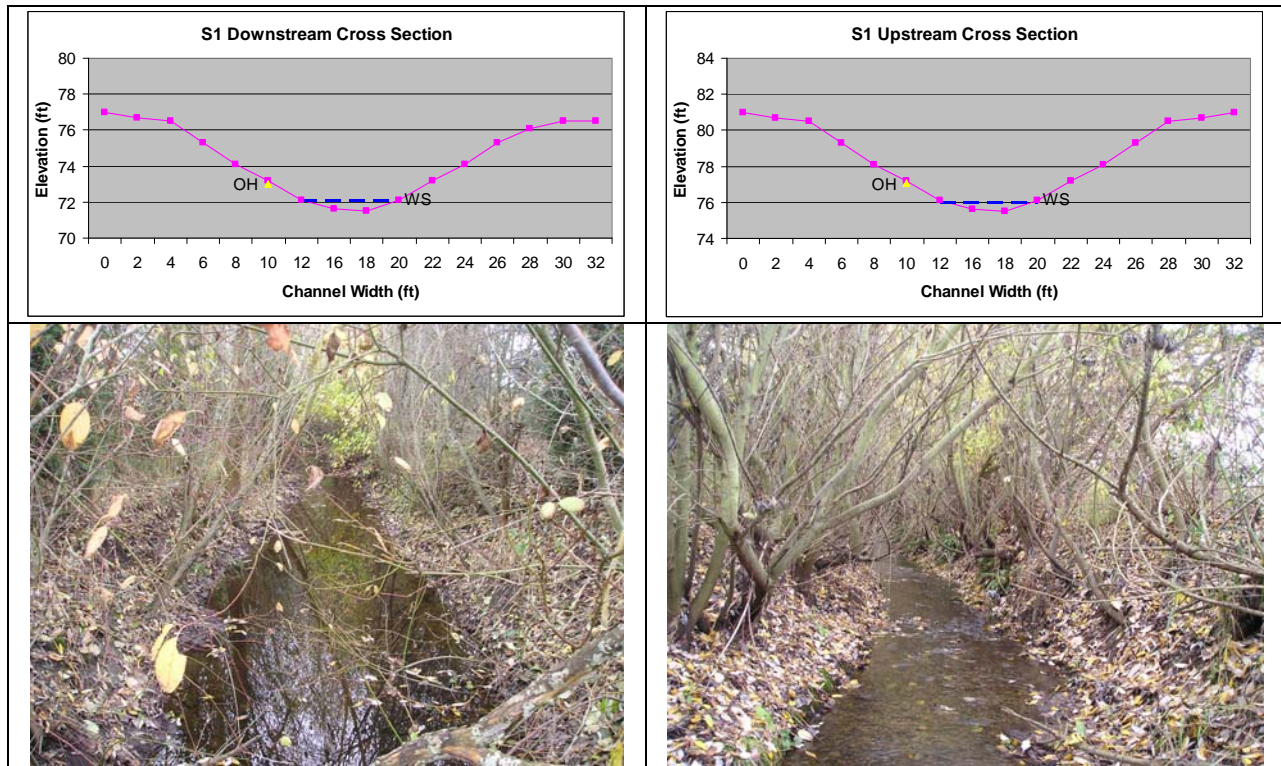
Reach S1 Silver Creek
	Existing Conditions
Reach Description	Begins at the northwest district boundary just south of Smith Rd and ends near the district mid point just east of Aldrich Rd.
Length	4,050 feet
Current Habitat Conditions	The channel has been modified and simplified via historic maintenance dredging activities. Significant piles of old dredge spoils parallel the channel in places. The channel width ranges from 8 feet to 12 feet. Large woody debris in the channel consists of a few pieces installed with riparian plantings and a few planted deciduous species that have fallen in the water. Although the channel is mostly shaded, water temperatures are high in the summer due to low gradient, lack of deep pools and lack of ground water interface.
Riparian Characteristics	The right and left banks have been planted with native trees and shrubs over the last 10 years. Buffers are typically 10' to 25' with three properties also having larger (CREP) buffers. Native trees and shrubs have generally replaced Reed canarygrass as the dominant feature. Approximately 2,100 feet was planted with only a narrow buffer of Willow species in the late 1990's. This area has the most consistent and effective shade in the reach but lacks the diversity needed for a proper functioning buffer.

Fish Passage Barriers & Obstacles	<ol style="list-style-type: none"> 1. One private culvert (1285105) located in Silver Creek (Andreason Ditch) is a fish passage barrier. Replacing the culvert would open 1,753 feet of habitat. 2. Six additional culverts were assessed and are not barriers (1285102, 1285103, 1285104, 1285106, 1285107, 1285108).
Spawning Habitat	Silts and fines dominate the channel substrate in Reach S1. Several small areas of gravel exist near the northwest district boundary and may provide limited spawning habitat for salmonid species.
Reach Fish Utilization	Salmonids have been observed upstream from Reach S1 near Larrabee Springs. These fish may have originated from Deer Creek, a Ten Mile Creek tributary to the north. Reach S1 is primarily a migration corridor and rearing habitat for Coho and Cutthroat.
