# **Whatcom County Drainage Improvement District #30A Drainage Management Plan**

**Drainage Improvement District #30A**

**Whatcom Conservation District**

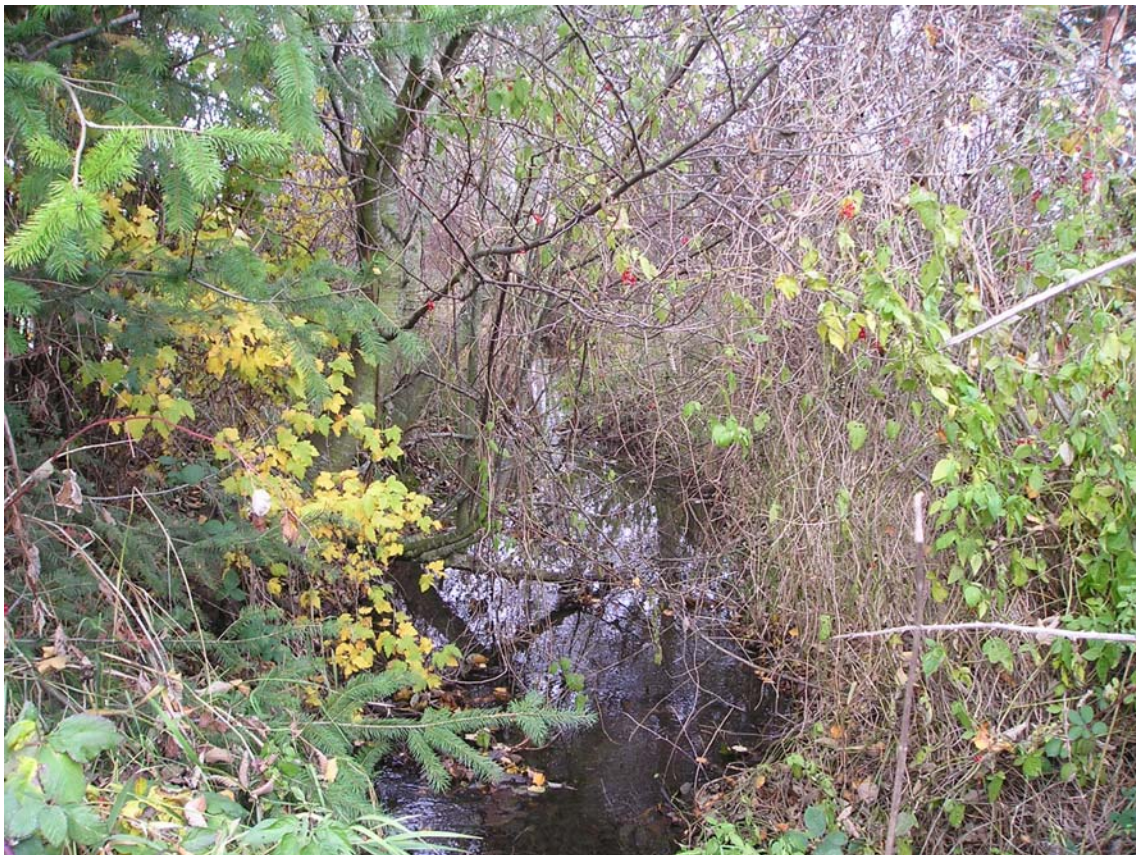
DID # 30A Modified Natural Watercourse

**Modified Natural Watercourses (Yellow):** The south fork of Deer Creek is a modified watercourse totaling 7,750 feet. DID #30A maintains 4,850 feet of modified watercourse.

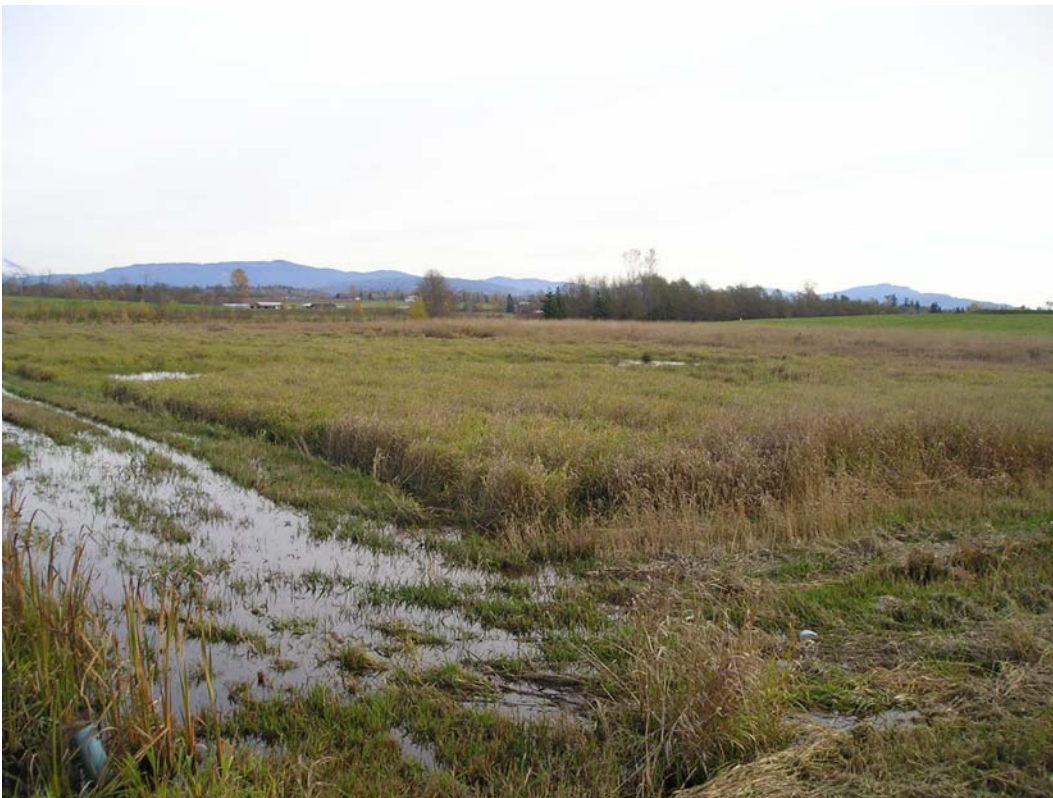
Typical farmed wetland in DID #30A

Figure 5 shows Whatcom County CAO wetlands in DID #30A. Wetland rating and delineations are beyond the scope of this plan. However most of these wetlands would probably be rated as III or IV with some possibly rated as II where native trees have been planted. Some of the wetlands are isolated and would not likely be impacted by drainage maintenance work. Some farmland adjacent to maintained watercourses have Prior Converted Wetland status and will be impacted by drainage maintenance work.

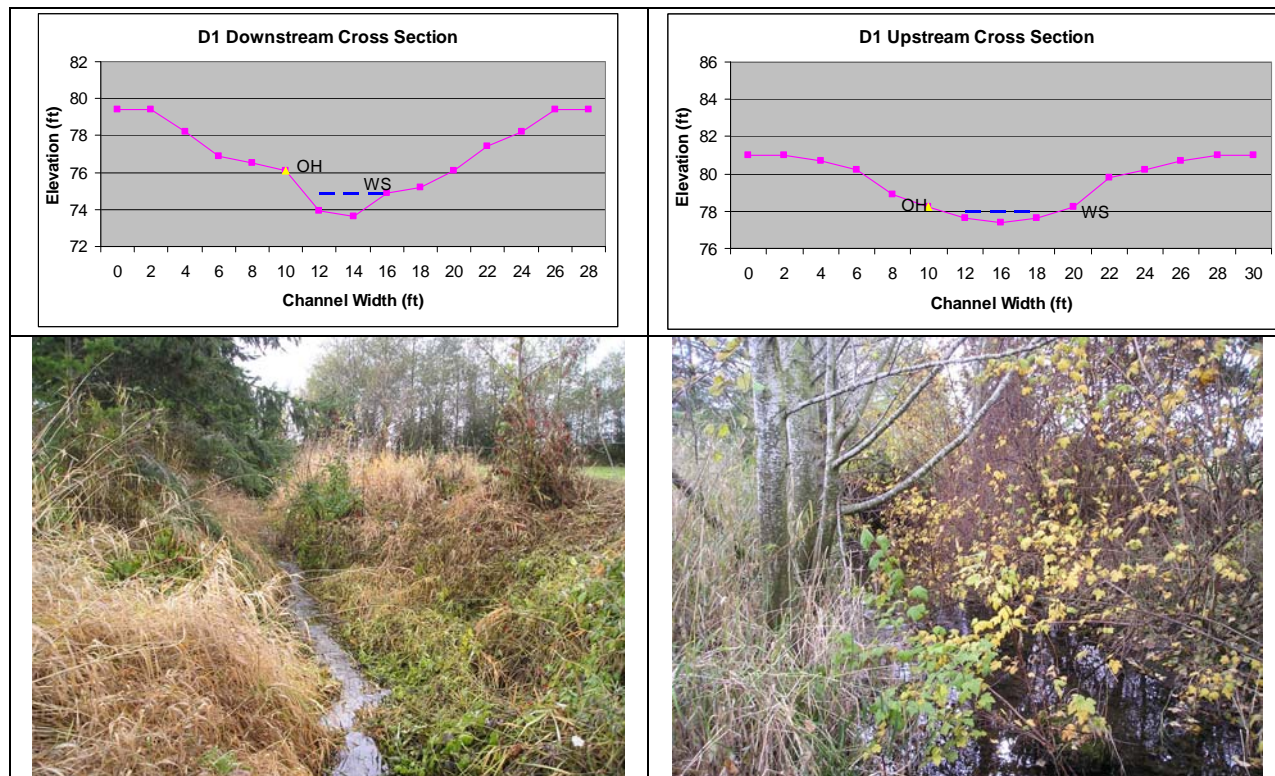
<b>Reach D1 South Fork Deer Creek</b>
	<b>Existing Conditions</b>
<b>Reach Description</b>	Begins at Smith Rd and extends to the approximate center of the DID #30A maintained area where the watercourse turns northwest.
<b>Length</b>	2,350 feet
<b>Current Habitat Conditions</b>	The channel has been modified and simplified via historic maintenance dredging activities. Significant piles of old dredge spoils parallel the channel in places. The channel width ranges from 6 feet to 12 feet. Large woody debris in the channel is absent. Elevated water temperatures would be expected during the summer due to the absence of adequate riparian cover. Land use practices in the south portion of this reach has resulted in shallow water on top of deep mucky field deposits.
<b>Riparian Characteristics</b>	Narrow buffers of native trees and shrubs have been planted along much of this reach in the past 10 years. Some areas have good canopy cover and little Reed canarygrass remaining on the streambanks or in the stream. Other areas are still primarily covered with Reed canarygrass and Nightshade. Approximately 600 feet of Reach D1 just downstream of Smith Rd was planted with native trees or shrubs by the landowner in the late summer of 2009.

<b>Fish Passage Barriers &amp; Obstacles</b>	<ol style="list-style-type: none"> <li>1. The Smith Rd culvert (370595) was assessed and is not a fish passage barrier.</li> <li>2. Two other known crossings have not been assessed.</li> </ol>
<b>Spawning Habitat</b>	Silts and fines dominate the channel substrate. Spawning habitat for salmonid species is not present.
<b>Reach Fish Utilization</b>	Primarily a migration corridor and rearing habitat for Coho and Cutthroat. Salmonids have been observed upstream from Reach D1. Habitat is limited by the absence of large woody debris in the channel and inadequate riparian vegetation. Elevated water temperatures and low dissolved oxygen levels during the summer may limit salmonid rearing opportunity.

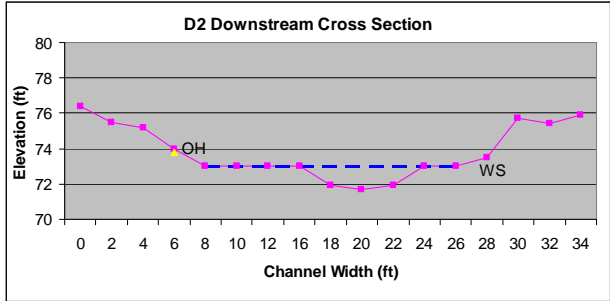
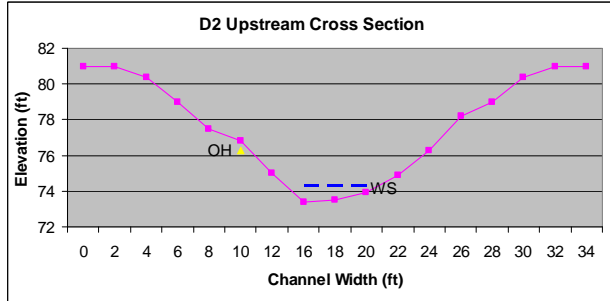
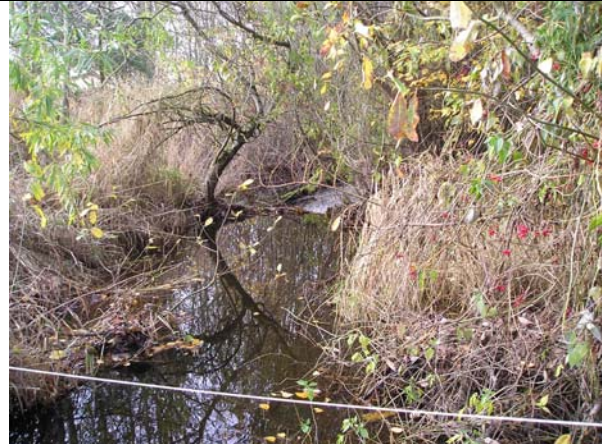
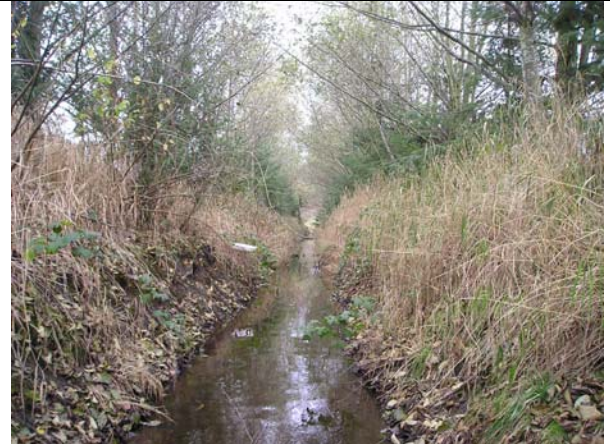
<b>Reach D2 South Fork Deer Creek</b>	
<b>Existing Conditions</b>	
<b>Reach Description</b>	Begins at the end of Reach D1 near the center of the district and ends at Aldrich Rd.
<b>Length</b>	2,450 feet
<b>Current Habitat Conditions</b>	The channel has been modified and simplified via historic maintenance dredging activities. Significant piles of old dredge spoils parallel the channel in places. The channel width ranges from 6 feet to 20 feet. Large woody debris was placed in the downstream most 1,000 feet in 2007 but is absent in the rest of the reach. Elevated water temperatures would be expected during the summer due to the inadequate riparian cover.
<b>Riparian Characteristics</b>	This entire reach has been successfully planted with native trees and shrubs. The upstream 1,500 feet was planted in the late 1990s with a narrow buffer that now shades over 90% of the channel. The downstream 1,000 feet was planted with large buffers in the spring of 2007. Early succession plants are beginning to shade the channel and there should be good shade in the next few years.

<b>Fish Passage Barriers &amp; Obstacles</b>	<ol style="list-style-type: none"> <li>1. The Aldrich Rd culvert (Site ID #370116) was assessed and is not a barrier.</li> <li>2. Two other known crossings (UNK30a-04, UNK30a-05) have not been assessed.</li> </ol>

<b>Spawning Habitat</b>	Silts and fines dominate the channel substrate. Spawning habitat for salmonid species is not present.
<b>Reach Fish Utilization</b>	Primarily a migration corridor and rearing habitat for Coho and Cutthroat. Salmonids have been observed upstream from Reach D2. Habitat is limited but improving with the addition of large woody debris and additional riparian planting. Elevated water temperatures and low dissolved oxygen levels from degraded upstream areas limit salmonid rearing opportunities.
