# **Whatcom County Drainage Improvement District #30 Drainage Management Plan**

**Drainage Improvement District #30**

**Whatcom Conservation District**

**Whatcom County Public Works**

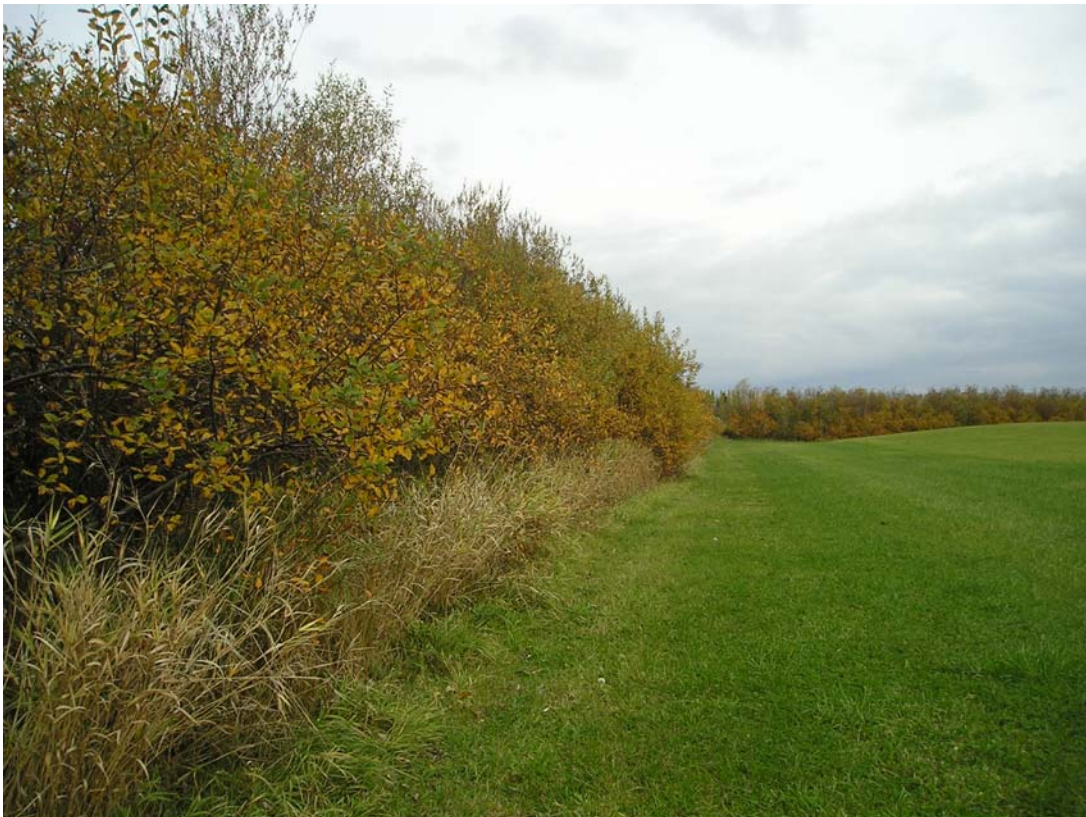
Hedgerow along a Modified Natural Watercourse in DID#30

**Modified Natural Watercourses (Yellow):** Silver Creek (Andreason Ditch) is a maintained district channel. 6,250 feet. In addition, 680 feet of Andreason Ditch is maintained downstream from the DID #30 boundary.

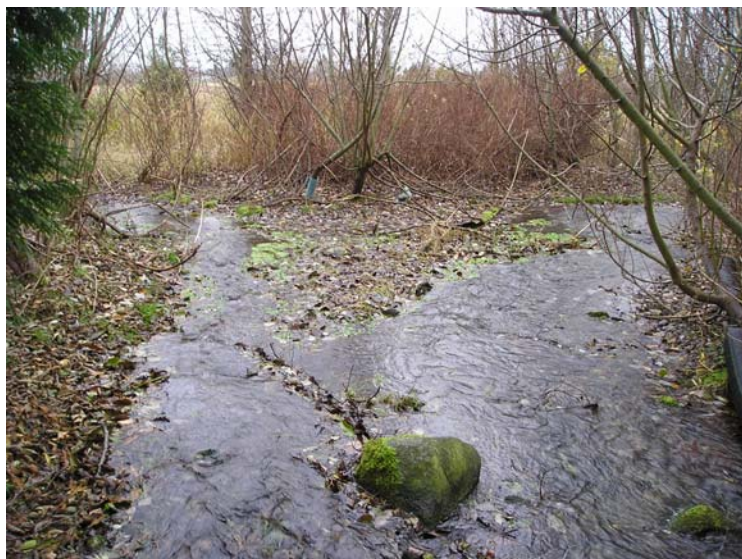
Silver Creek (left) & Deer Creek (right) rock diversion

**Other Infrastructure** – A rock diversion exists near the northwest district boundary. Water from Larrabee springs is divided into the headwaters of both Silver Creek and the south fork of Deer Creek.

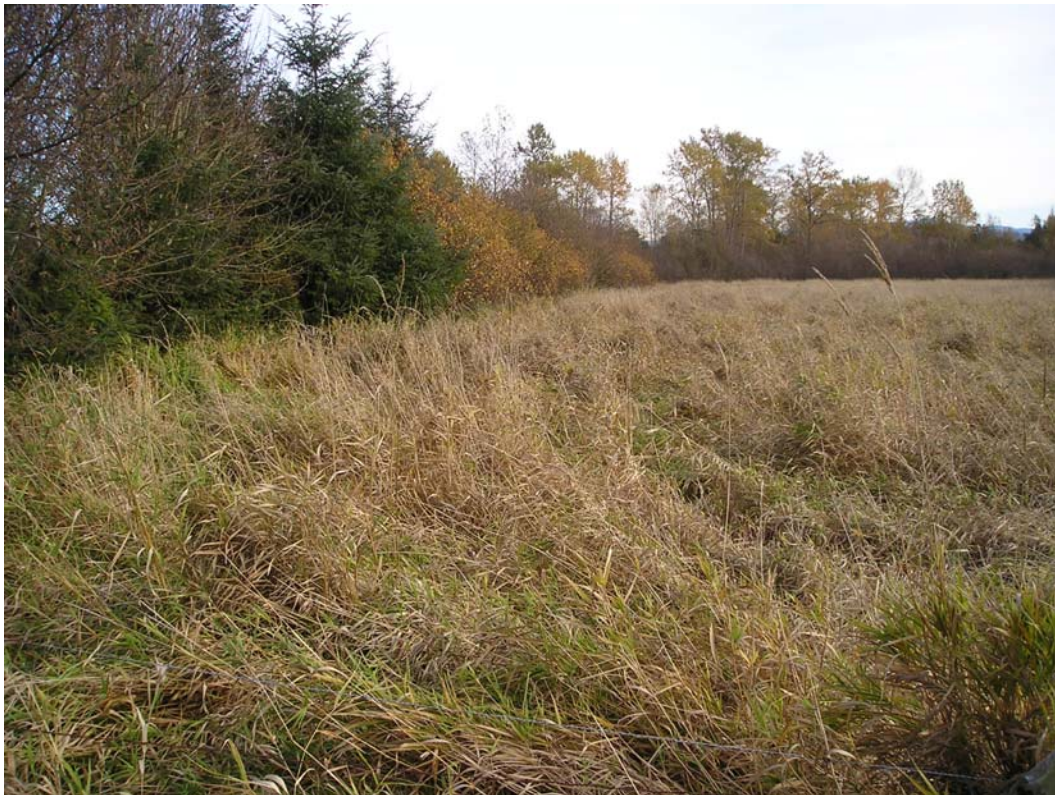
Typical farmed wetland in DID #30

Figure 5 shows Whatcom County CAO wetlands in DID #30. Wetland rating and delineations are beyond the scope of this plan. However most of these wetlands would probably be rated as III or IV with some possibly rated as II where native trees have grown or have been planted. Many of the wetlands are isolated and would not likely be impacted by drainage maintenance work. Some farmland adjacent to maintained watercourses have Prior Converted Wetland status and will be impacted by continued drainage maintenance work.

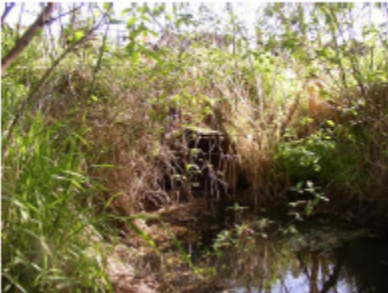
Site ID:	1285105	Shape:	RND	
	Stream:	Unnamed	Material:	CAL	
	Trib To:	Silver Cr	Span (m):	1.22	
	Owner:	Private	Length (m):	7.15	
		BARRIER STATUS	HABITAT GAIN		
		Problem:	Slope	Lineal Gain (m):	1,753
		Ds Barriers:	3	Spawn Area (m2):	1,416
		Us Barriers:	0	Rear Area (m2):	1,337

<b>Fish Passage Barriers &amp; Obstacles</b>	<ol style="list-style-type: none"> <li>1. One private culvert (1285105) located in Silver Creek (Andreason Ditch) is a fish passage barrier. Replacing the culvert would open 1,753 feet of habitat.</li> <li>2. Six additional culverts were assessed and are not barriers (1285102, 1285103, 1285104, 1285106, 1285107, 1285108).</li> </ol>
<b>Spawning Habitat</b>	Silts and fines dominate the channel substrate in Reach S1. Several small areas of gravel exist near the northwest district boundary and may provide limited spawning habitat for salmonid species.
<b>Reach Fish Utilization</b>	Salmonids have been observed upstream from Reach S1 near Larrabee Springs. These fish may have originated from Deer Creek, a Ten Mile Creek tributary to the north. Reach S1 is primarily a migration corridor and rearing habitat for Coho and Cutthroat.

3. Contact landowner in Reach S1 and seek participation to replace culvert #1285105.
4. Seek funding to replace culvert #1285105.
5. Assist with permitting and replace culvert #1285105.
