# **Whatcom County Drainage Improvement District #30A Drainage Management Plan**

**Drainage Improvement District #30A**

**Whatcom Conservation District**

**Whatcom County Public Works**

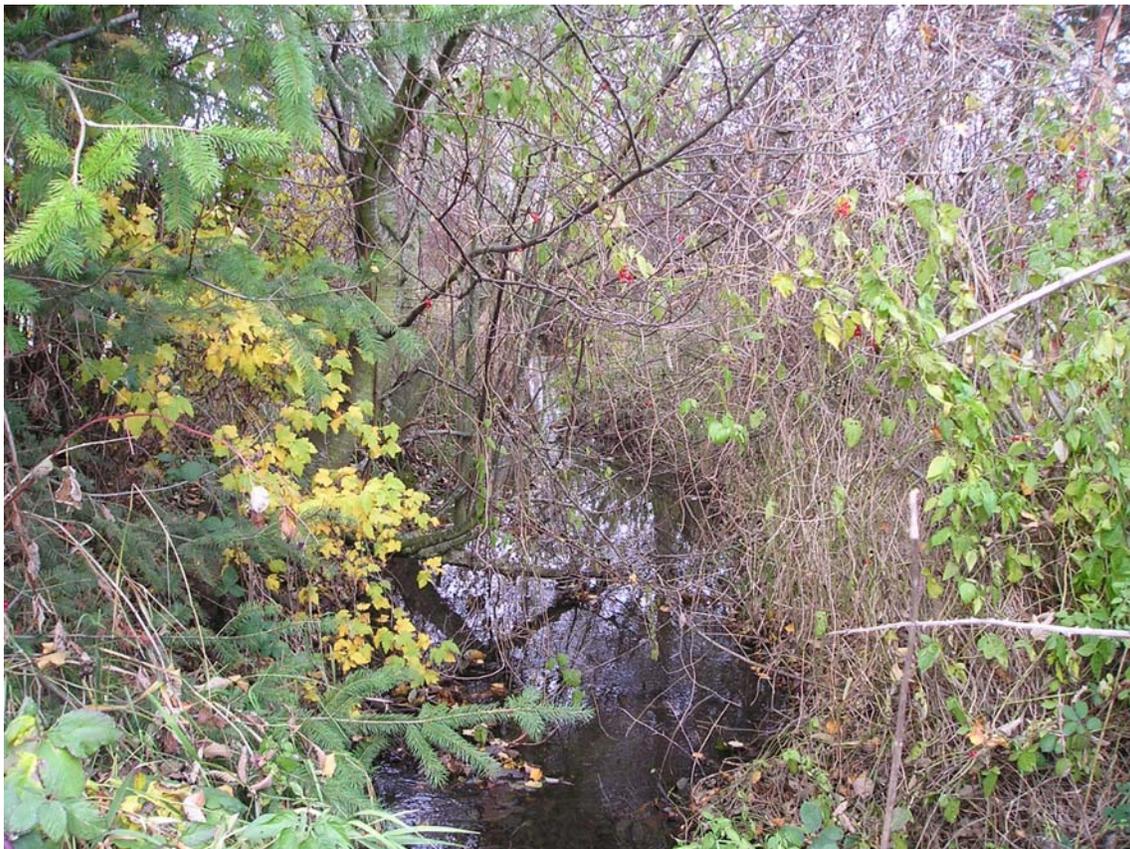
DID # 30A Modified Natural Watercourse

**Modified Natural Watercourses (Yellow):** The south fork of Deer Creek is a modified watercourse totaling 7,750 feet. DID #30A maintains 4,850 feet of modified watercourse.

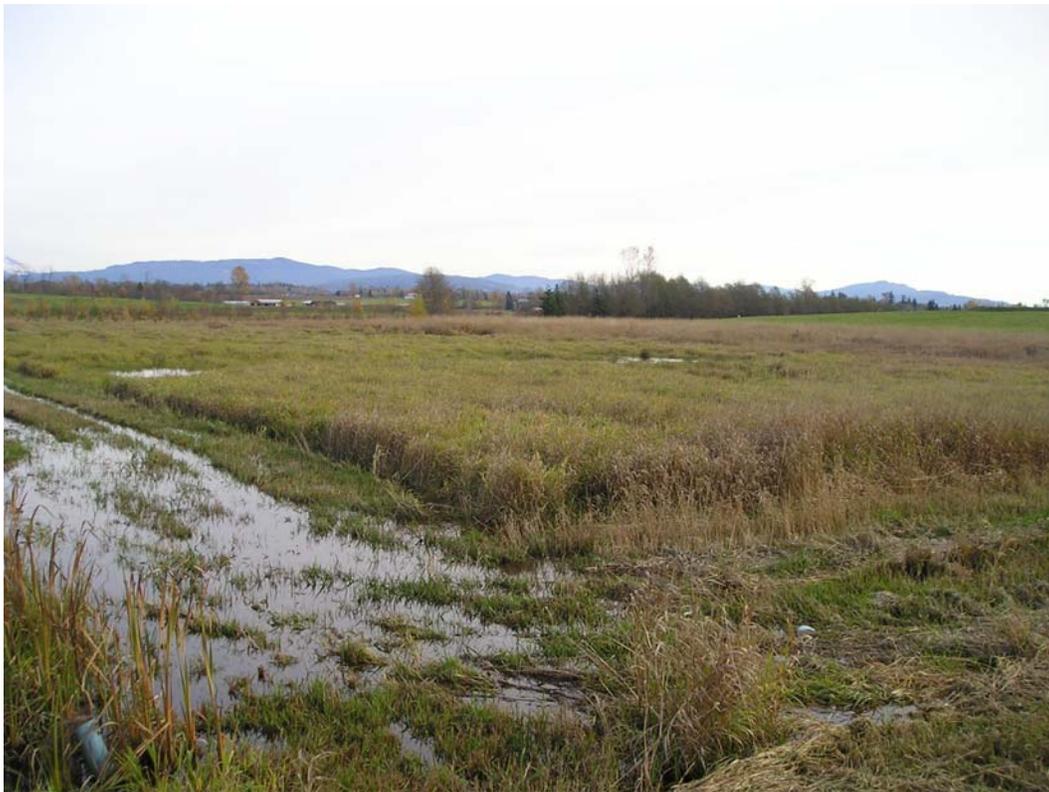
Typical farmed wetland in DID #30A

Figure 5 shows Whatcom County CAO wetlands in DID #30A. Wetland rating and delineations are beyond the scope of this plan. However most of these wetlands would probably be rated as III or IV with some possibly rated as II where native trees have been planted. Some of the wetlands are isolated and would not likely be impacted by drainage maintenance work. Some farmland adjacent to maintained watercourses have Prior Converted Wetland status and will be impacted by drainage maintenance work.

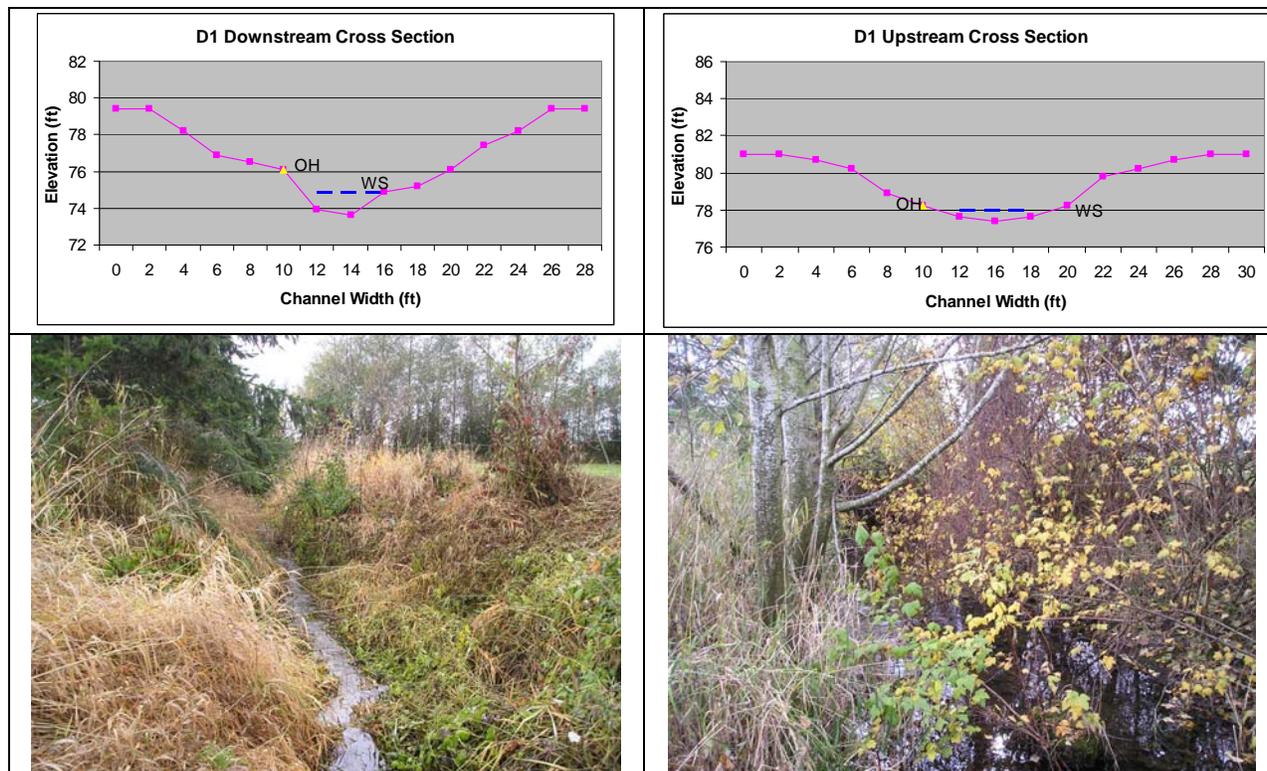
<b>Reach D1 South Fork Deer Creek</b>
	<b>Existing Conditions</b>
<b>Reach Description</b>	Begins at Smith Rd and extends to the approximate center of the DID #30A maintained area where the watercourse turns northwest.
<b>Length</b>	2,350 feet
<b>Current Habitat Conditions</b>	The channel has been modified and simplified via historic maintenance dredging activities. Significant piles of old dredge spoils parallel the channel in places. The channel width ranges from 6 feet to 12 feet. Large woody debris in the channel is absent. Elevated water temperatures would be expected during the summer due to the absence of adequate riparian cover. Land use practices in the south portion of this reach has resulted in shallow water on top of deep mucky field deposits.
<b>Riparian Characteristics</b>	Narrow buffers of native trees and shrubs have been planted along much of this reach in the past 10 years. Some areas have good canopy cover and little Reed canarygrass remaining on the streambanks or in the stream. Other areas are still primarily covered with Reed canarygrass and Nightshade. Approximately 600 feet of Reach D1 just downstream of Smith Rd was planted with native trees or shrubs by the landowner in the late summer of 2009.

<b>Fish Passage Barriers &amp; Obstacles</b>	<ol style="list-style-type: none"> <li>1. The Smith Rd culvert (370595) was assessed and is not a fish passage barrier.</li> <li>2. Two other known crossings have not been assessed.</li> </ol>
<b>Spawning Habitat</b>	Silts and fines dominate the channel substrate. Spawning habitat for salmonid species is not present.
<b>Reach Fish Utilization</b>	Primarily a migration corridor and rearing habitat for Coho and Cutthroat. Salmonids have been observed upstream from Reach D1. Habitat is limited by the absence of large woody debris in the channel and inadequate riparian vegetation. Elevated water temperatures and low dissolved oxygen levels during the summer may limit salmonid rearing opportunity.

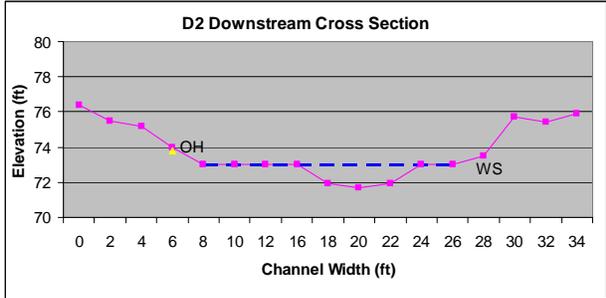
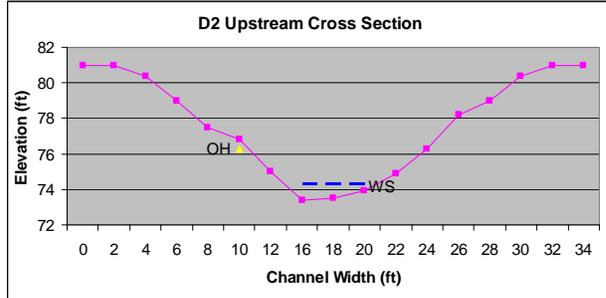
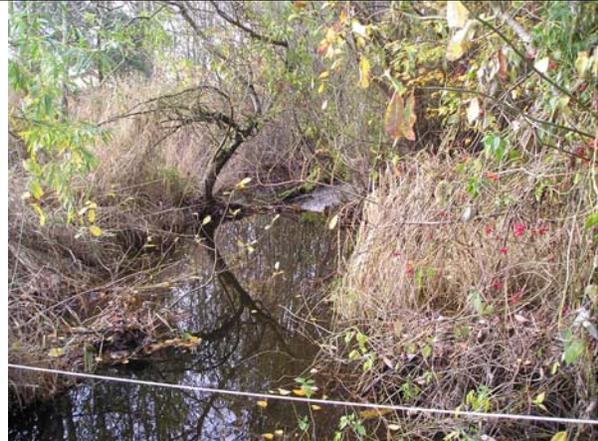
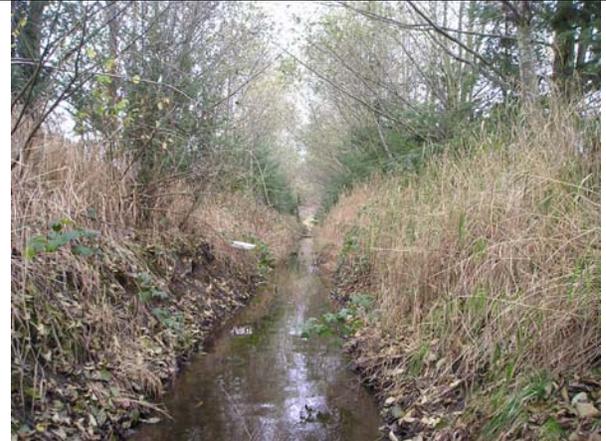
<b>Reach D2 South Fork Deer Creek</b>	
<b>Existing Conditions</b>	
<b>Reach Description</b>	Begins at the end of Reach D1 near the center of the district and ends at Aldrich Rd.
<b>Length</b>	2,450 feet
<b>Current Habitat Conditions</b>	The channel has been modified and simplified via historic maintenance dredging activities. Significant piles of old dredge spoils parallel the channel in places. The channel width ranges from 6 feet to 20 feet. Large woody debris was placed in the downstream most 1,000 feet in 2007 but is absent in the rest of the reach. Elevated water temperatures would be expected during the summer due to the inadequate riparian cover.
<b>Riparian Characteristics</b>	This entire reach has been successfully planted with native trees and shrubs. The upstream 1,500 feet was planted in the late 1990s with a narrow buffer that now shades over 90% of the channel. The downstream 1,000 feet was planted with large buffers in the spring of 2007. Early succession plants are beginning to shade the channel and there should be good shade in the next few years.

<b>Fish Passage Barriers &amp; Obstacles</b>	<ol style="list-style-type: none"> <li>1. The Aldrich Rd culvert (Site ID #370116) was assessed and is not a barrier.</li> <li>2. Two other known crossings (UNK30a-04, UNK30a-05) have not been assessed.</li> </ol>

<b>Spawning Habitat</b>	Silts and fines dominate the channel substrate. Spawning habitat for salmonid species is not present.
<b>Reach Fish Utilization</b>	Primarily a migration corridor and rearing habitat for Coho and Cutthroat. Salmonids have been observed upstream from Reach D2. Habitat is limited but improving with the addition of large woody debris and additional riparian planting. Elevated water temperatures and low dissolved oxygen levels from degraded upstream areas limit salmonid rearing opportunities.
